# Historic Chapel Renovation

New copper cladding aids in fixing chronic moisture issues

U.S. Naval Academy Chapel Dome Rehabilitation, Annapolis, Md.

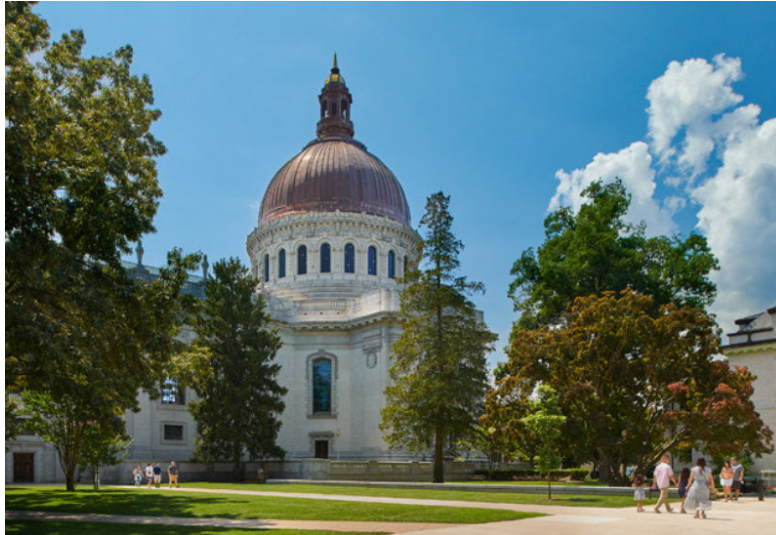
Photo: Anice Hoachlander

The United States Naval Academy Chapel in Annapolis, Md., was designed by architect Ernest Flagg and built from 1904–1908. Located on the grounds of the Navy’s service academy, the chapel played a vital role in its designation as a National Historic Landmark in July 1961. The chapel’s copper-clad dome highlights the grounds and is a dominant feature of the Annapolis landscape.

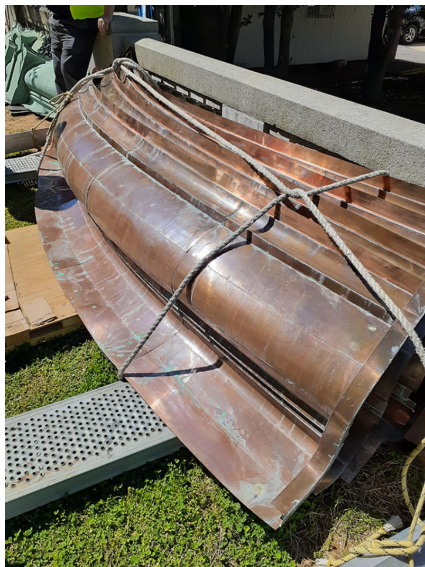
Photo: Anice Hoachlander

The Naval Academy needed a solution to the chronic moisture problems that would respect the past, while developing a patina seen throughout the state capital, which would serve the institution with a low-maintenance, long-lasting roof for decades to come. For the project, the Navy engaged Rogers, Lovelock & Fritz Inc. (<https://www.rlfarchitects.com/>), Orlando, Fla., to provide AE services, who turned to BELL Architects PC (<http://www.bellarchitects.com>), Washington, D.C., to serve as the lead architect.

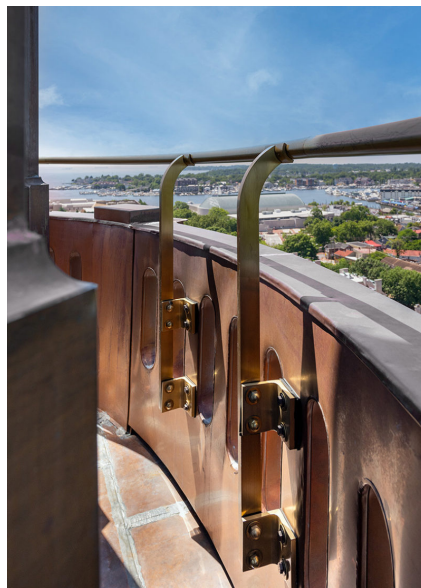
Photo: Anice Hoachlander

and masonry sock reinforcement at the parapets along the perimeter of the dome and nave, in addition to the replication of gold-leafed ornamentation at the lantern with an integrated lightning protection system.

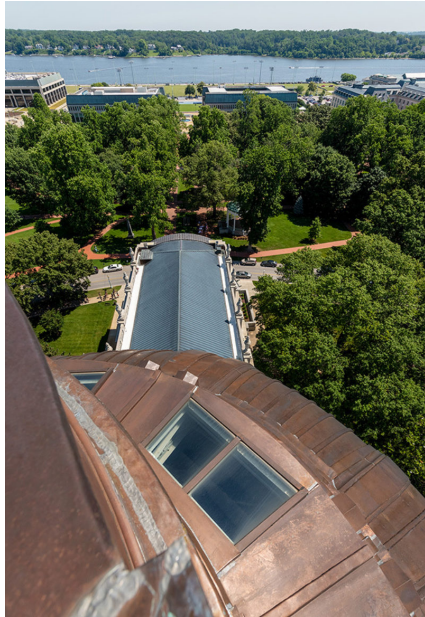
Photo: Anice Hoachlander

The project required 20,000 square feet of 20-ounce soft copper sheets from [Revere Copper Products Inc.](https://reverecopper.com/) (<https://reverecopper.com/>), Rome, N.Y. The H00 copper-rolled sheets were temper-formed to match the historic profiles. Additionally, the project used 50 feet of Brass-Alloy 385 tubes and plates that were used for the custom-fabricated guardrail.

The copper was installed starting at the base with relatively large, flat panels and progressed to the field of batten seam roofing. According to Dave Fyffe, principal, [Seal](https://seal-eng.com/)

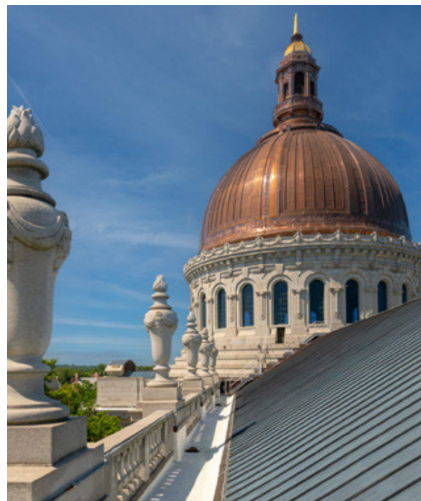
Photo: Anice Hoachlander

Another challenge, Kaltreider says, was retaining augmented natural light within the dome. "The skylights were a source of deterioration and water infiltration," he explains. "It

was a challenge to design details and collaborate with the installers to meet the historical copper configurations while being watertight, safe and secure.”
